Finite Element Analysis of an F-111 Lower Wing Skin Fatigue Crack Repair

R.J. Callinan, S. Sanderson and D. Keeley

**DSTO-TN-0067**

January 1997

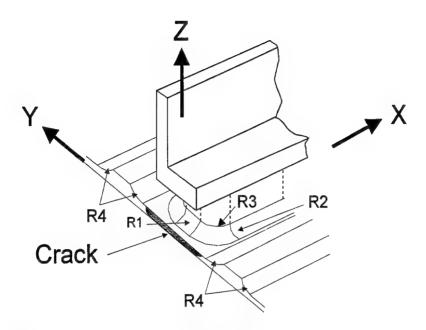
A section view of this area is shown in Figure 2, in which the y axis is in the chordwise direction, the x axis is in the spanwise direction and z axis is in the thickness direction. The crack is shaded and shown in the yz plane.

Figure 2 Detail section view of crack and fuel flow hole area.
